Pilot restoration project in a key fertile valley of the Highland Savanna

The Auas-Oanob Conservancy

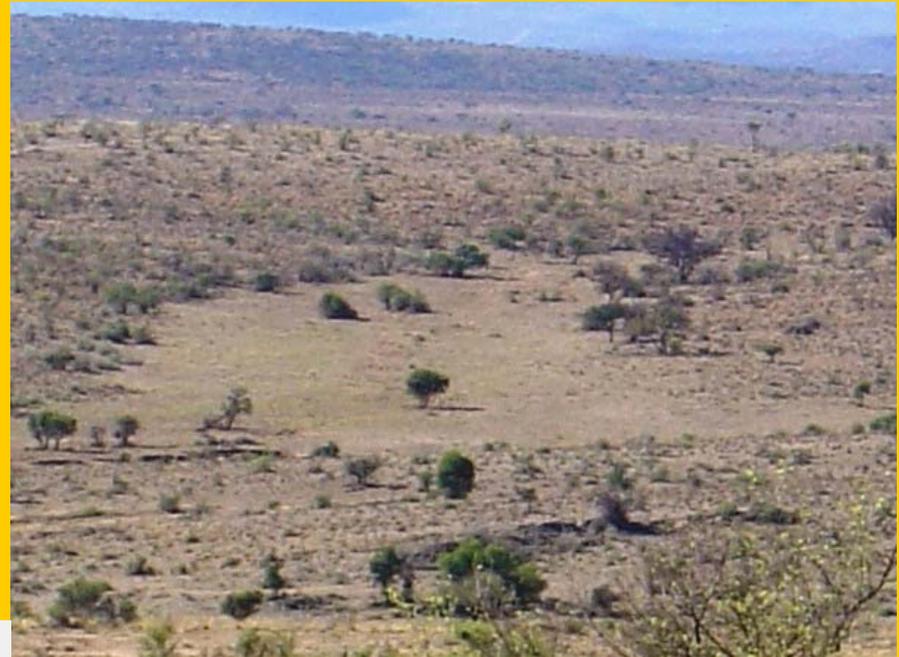
**Grassy upland
fertile valley
acts as a
benchmark,
providing a
vision for
restoration of
eroded valleys**

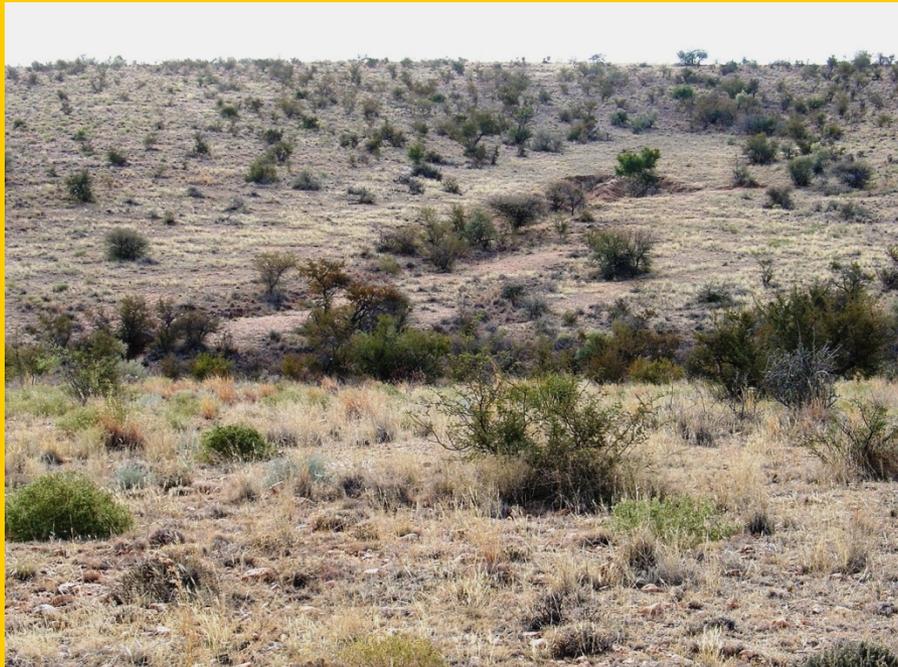
**Gully erosion
drains an upland
valley, allowing
bushes to take
over where
temporary
waterlogging had
excluded them**

- Preventative rangeland management should be a priority to avoid rangeland degradation
- But sometimes removal of causes is insufficient to bring about significant improvement ..
- .. because conditions still prevent the establishment of perennial grass cover
- In the pilot gully system, erosion removes valuable water, soil and seeds
- So this project treats symptoms too

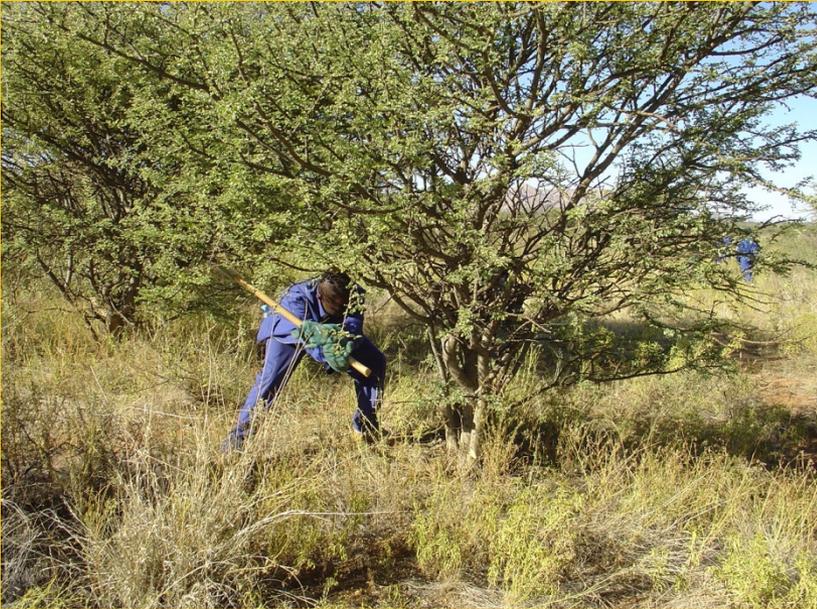
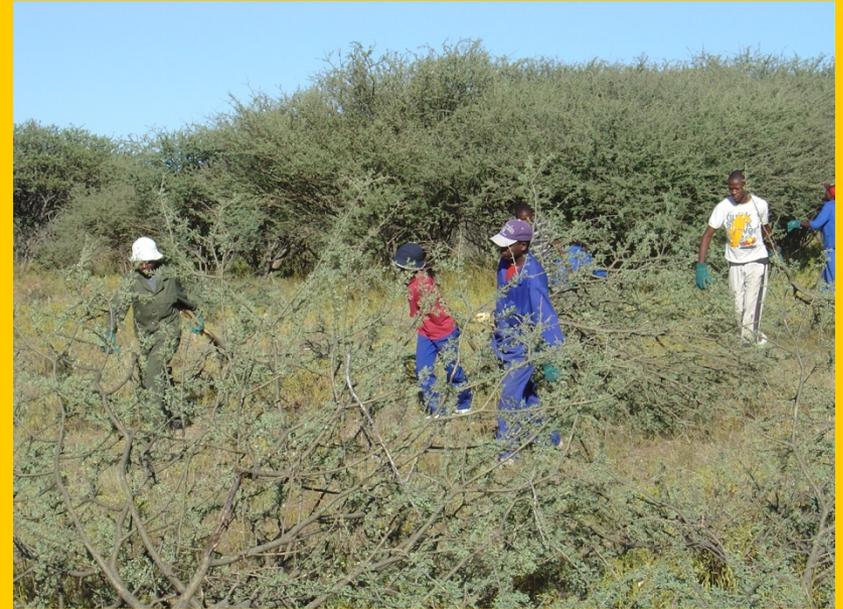
Branches of *Acacia mellifera* get placed in both

gullies

and

rills

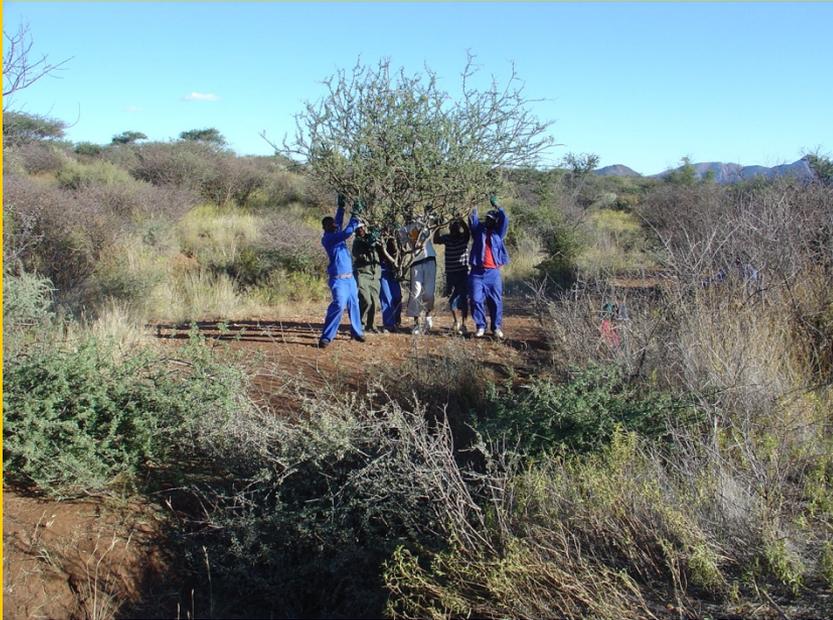
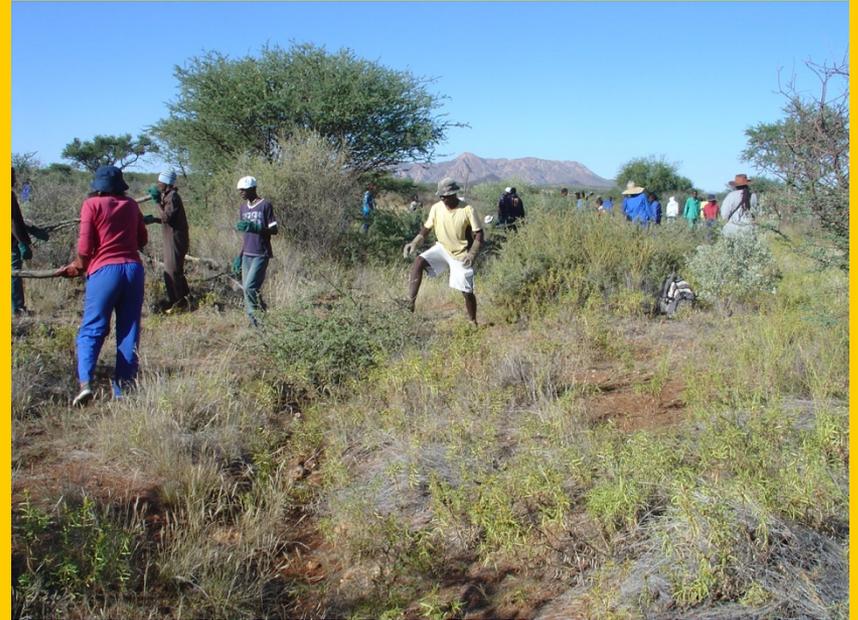
Branches were stacked for water to go through, not around

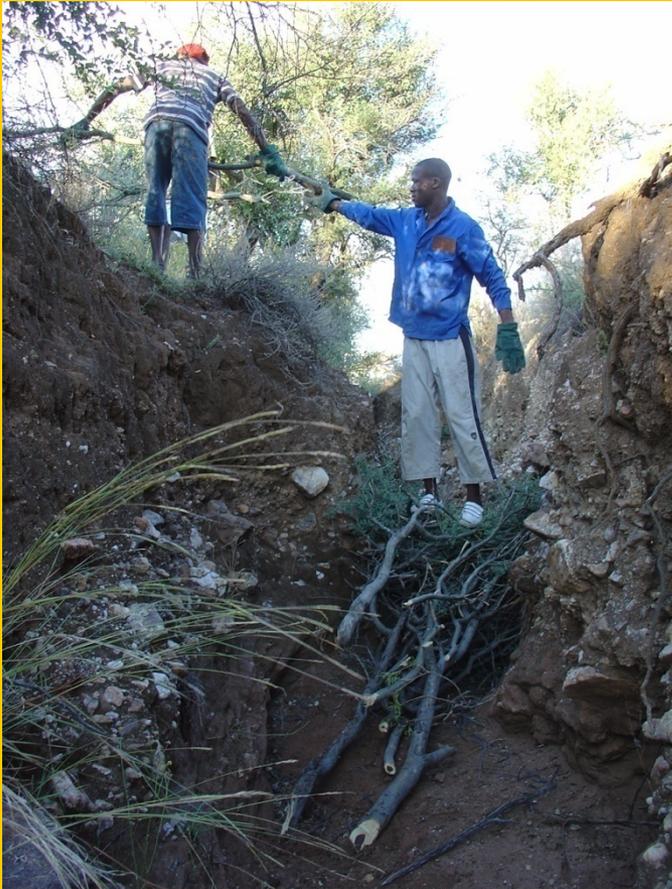
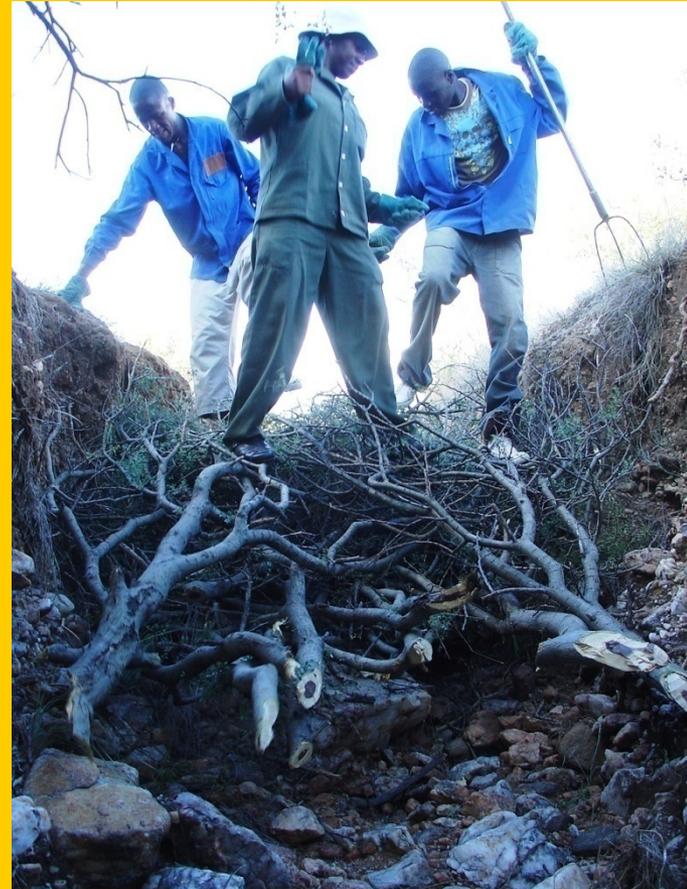
Filters must be strong to calm turbulence at a confluence

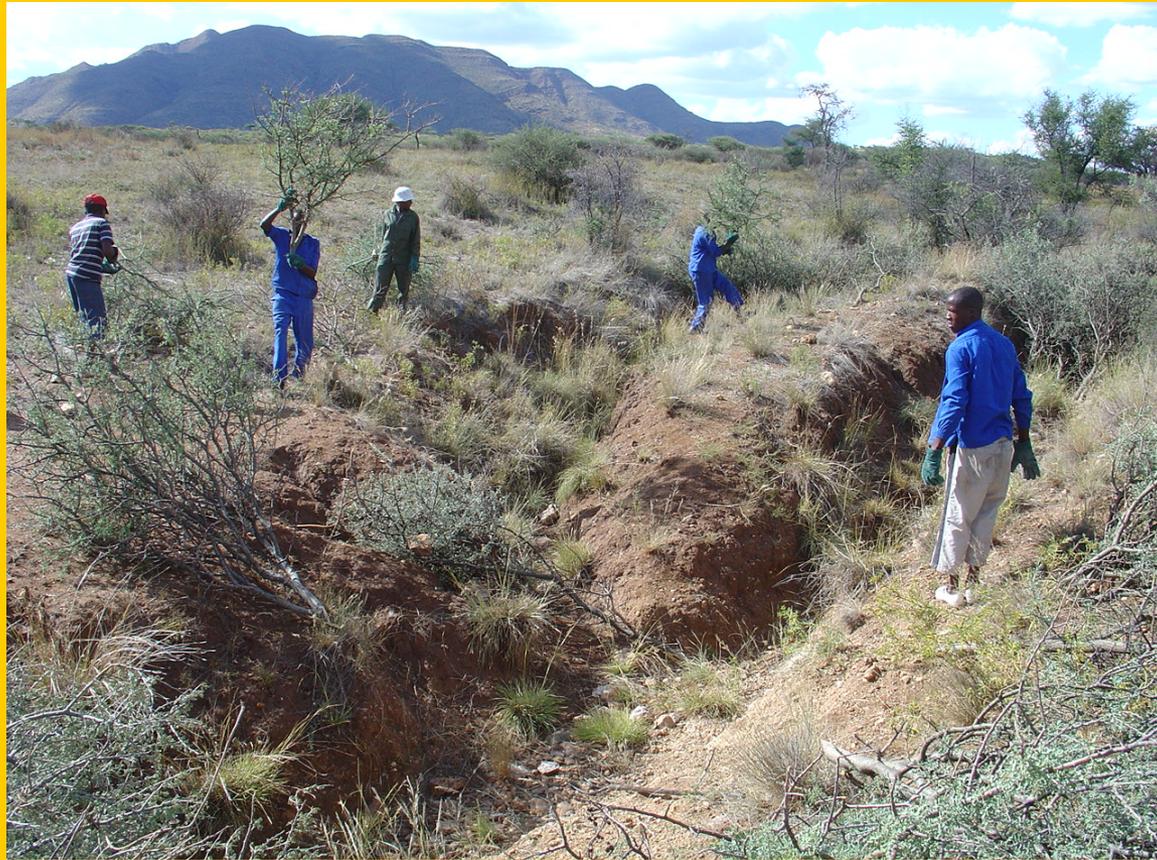
Wire gets woven through a filter, to hold branches together

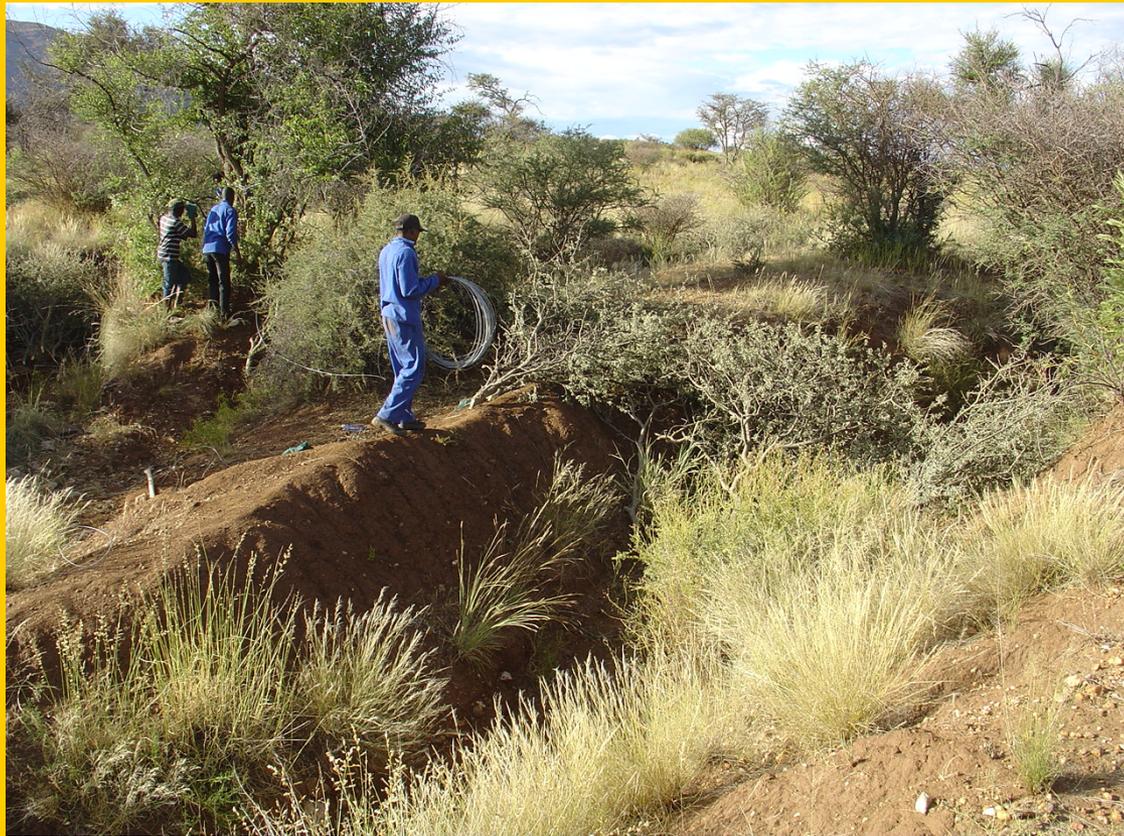
Filters get tied with wire to nearby trees

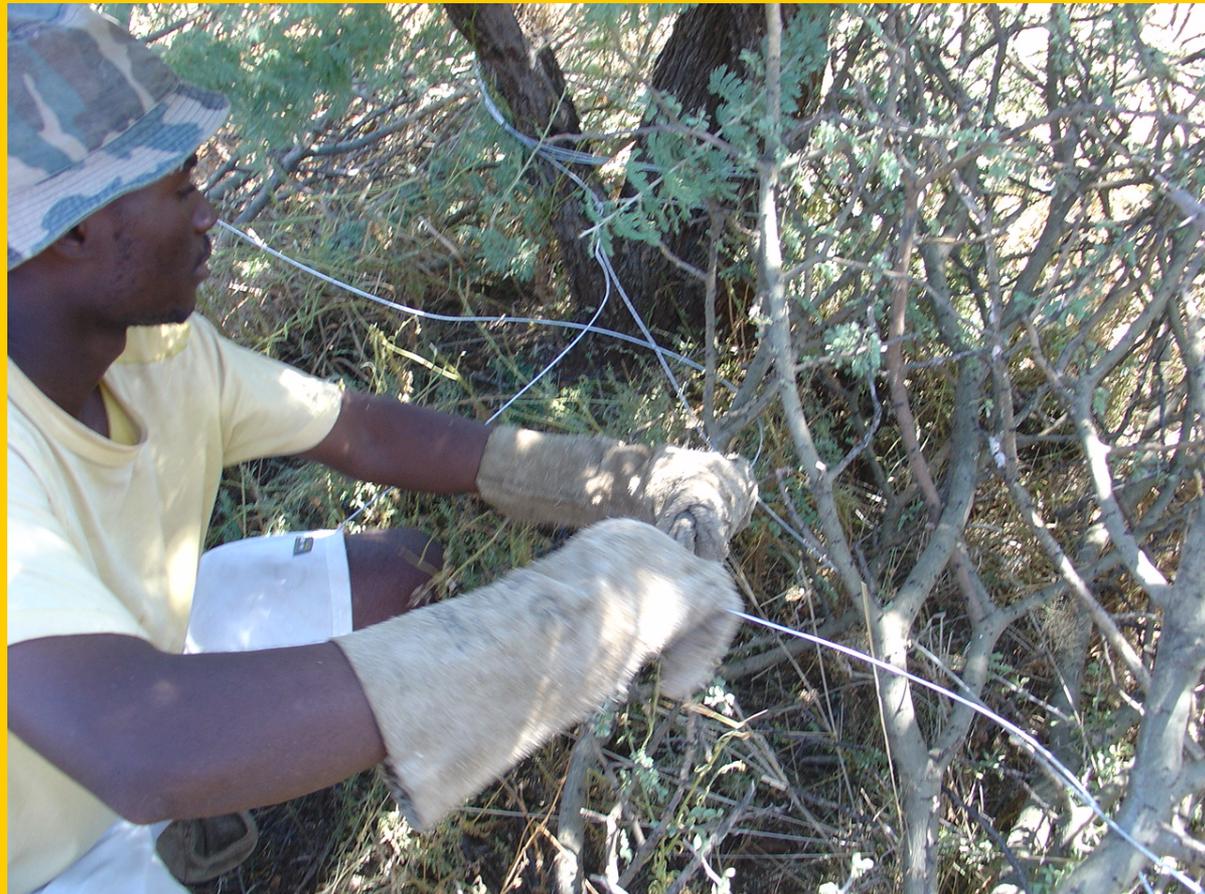
Where there was no tree nearby, a steel post serves as anchor

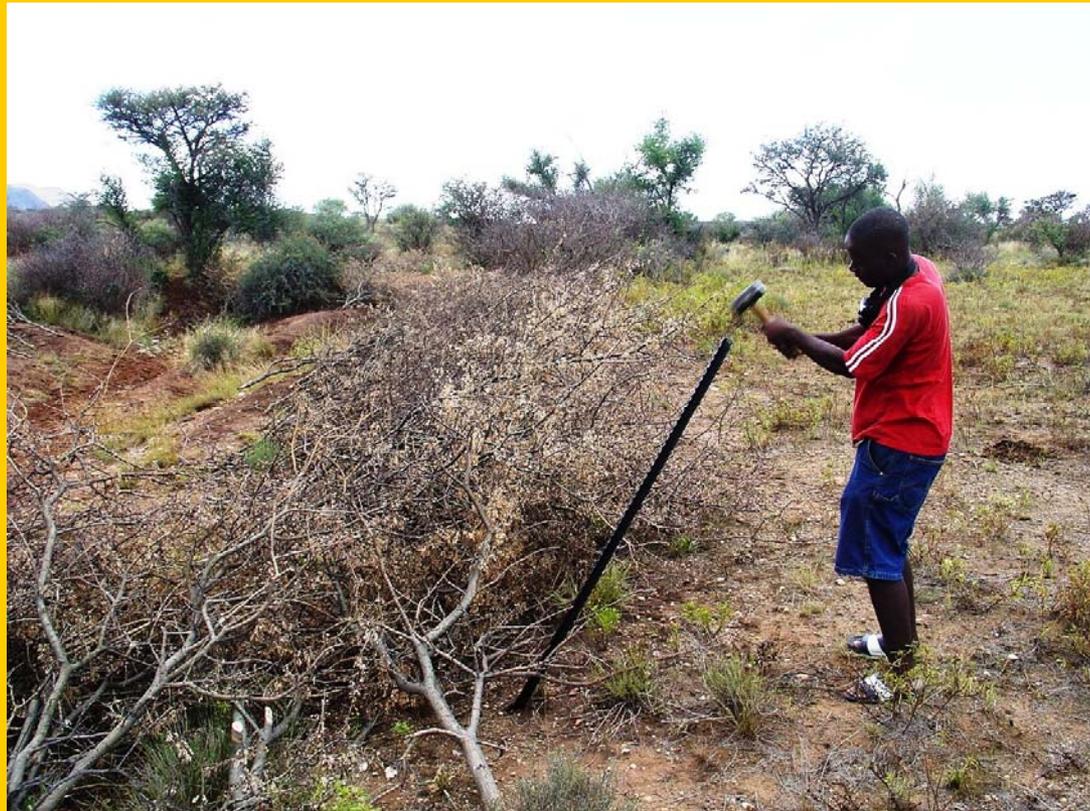
At critical locations the filter extends well beyond the gully

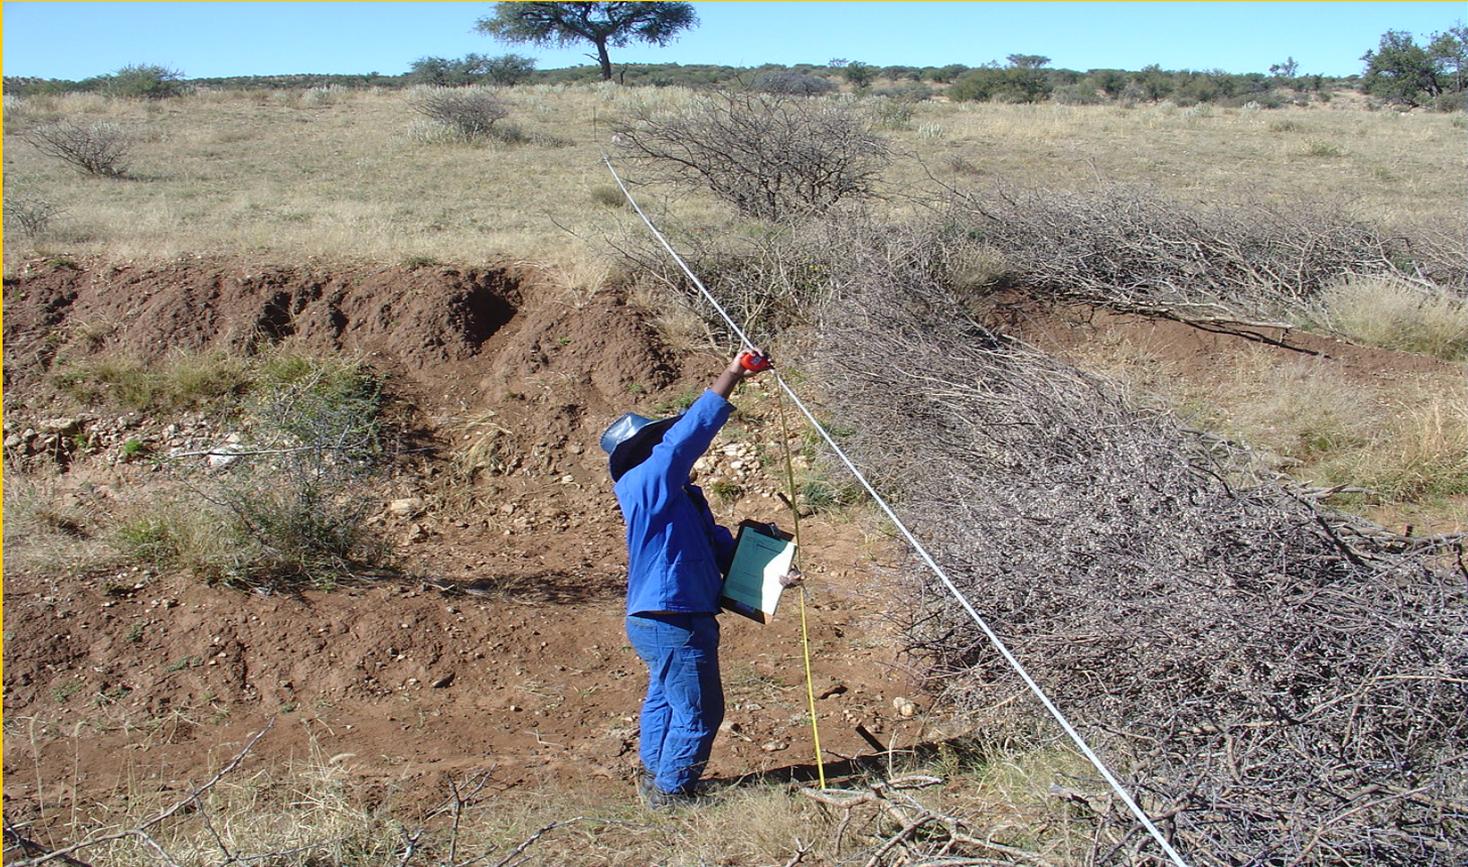
Gully depth was measured at regular intervals along transects

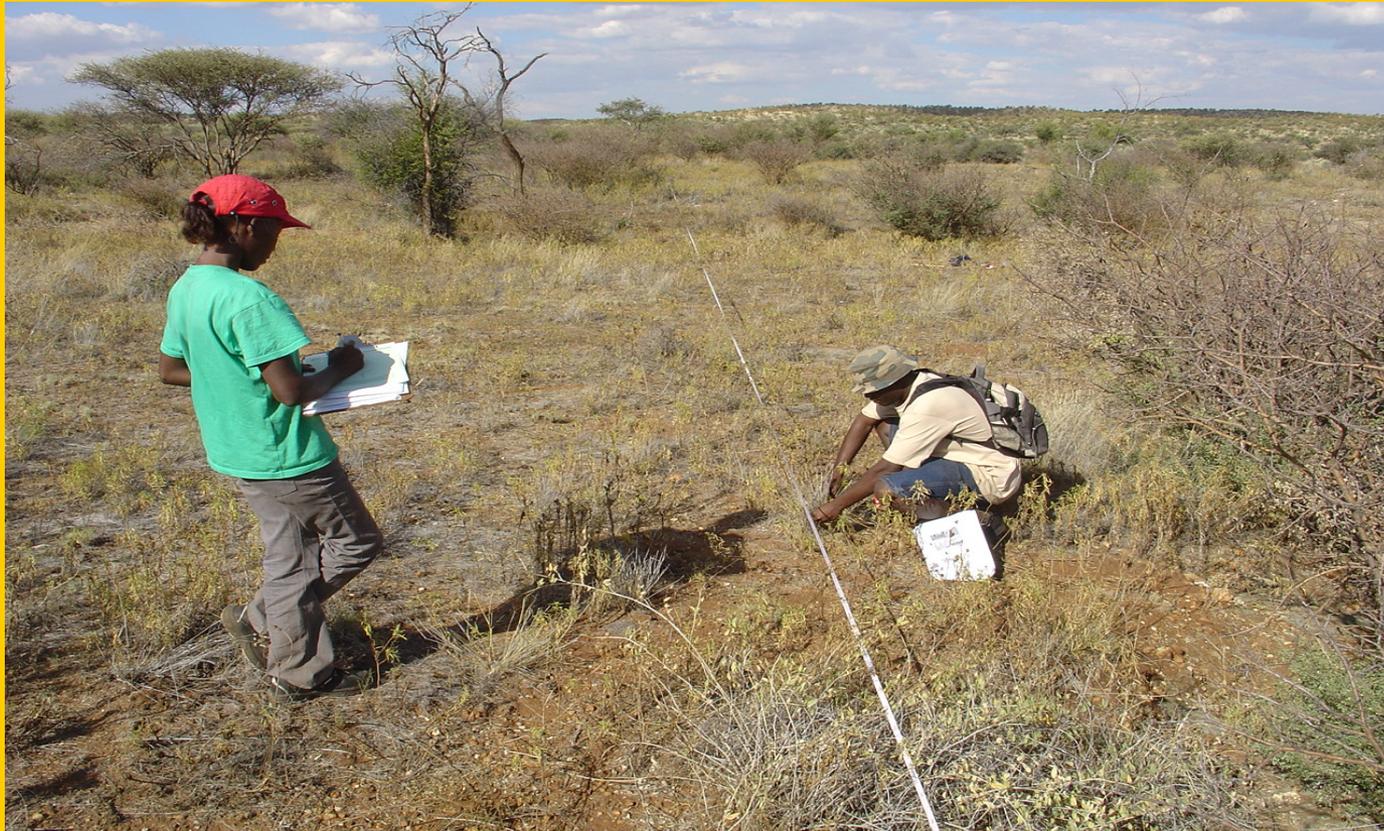
Landscape Function Analysis across the rills and gullies

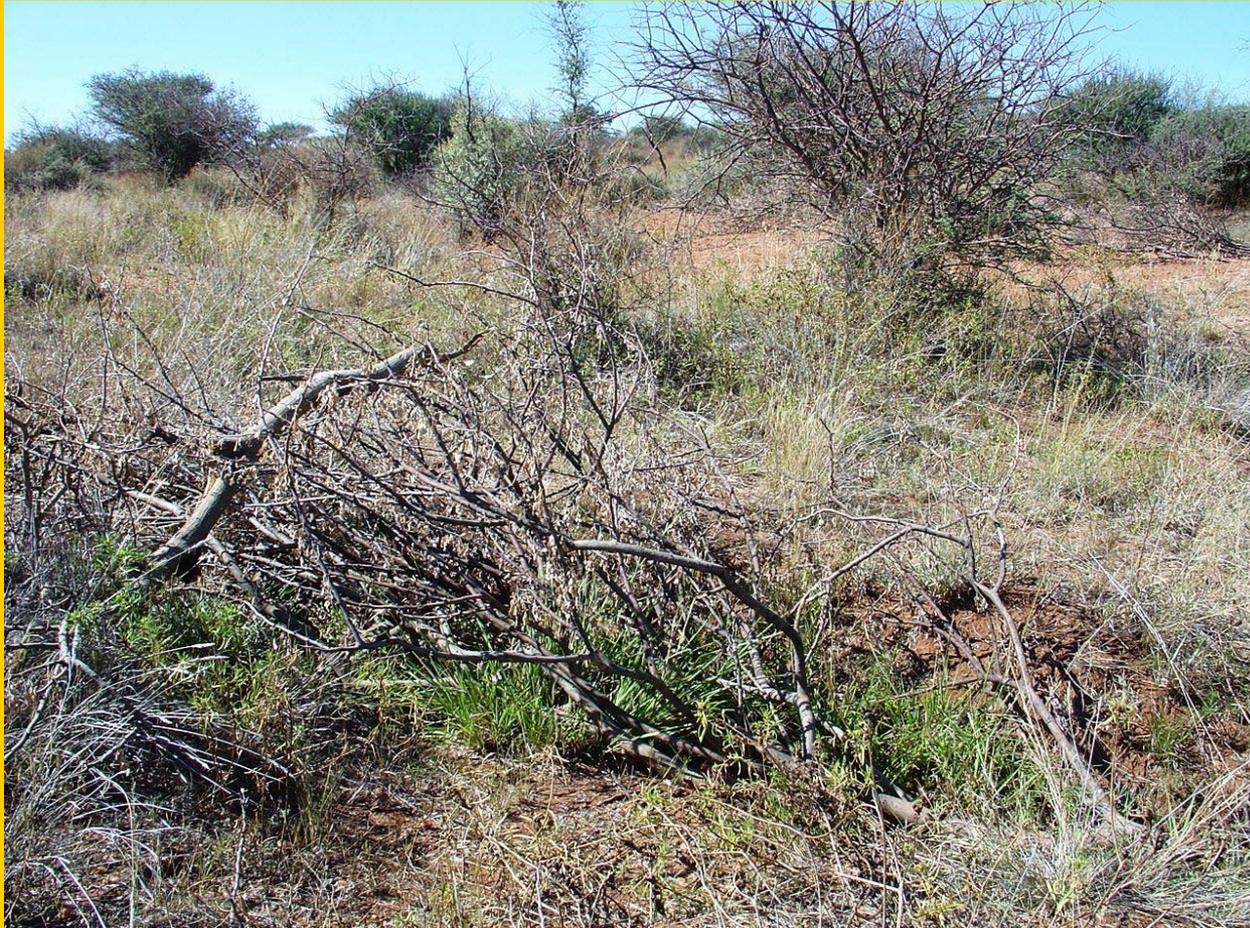
**After only 20mm of rain at
poor start of 2007/08 season**

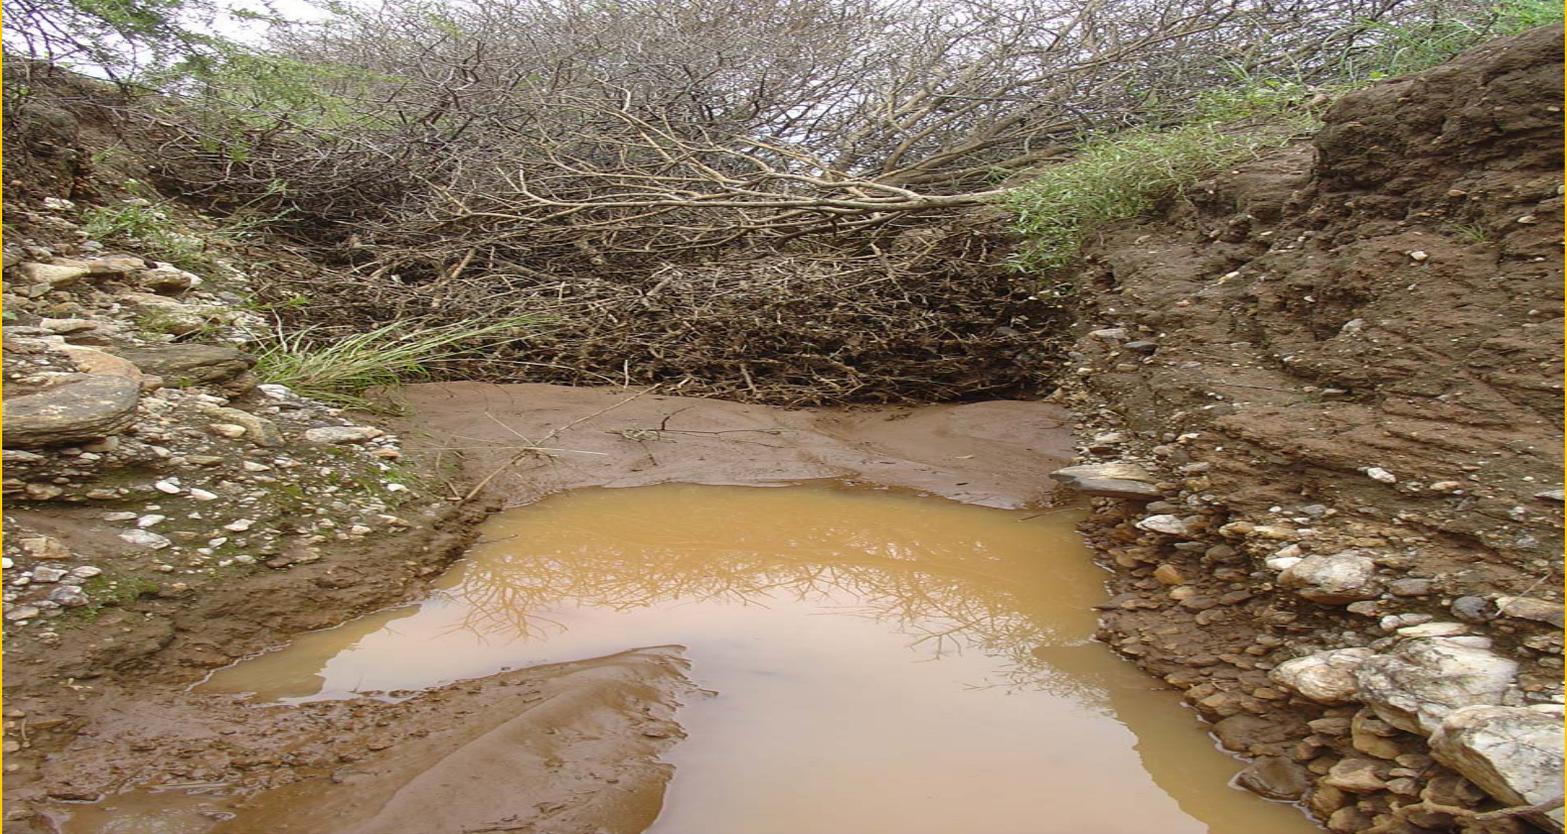
**Then in March 2008 about 50mm
of rain fell in 30 minutes**

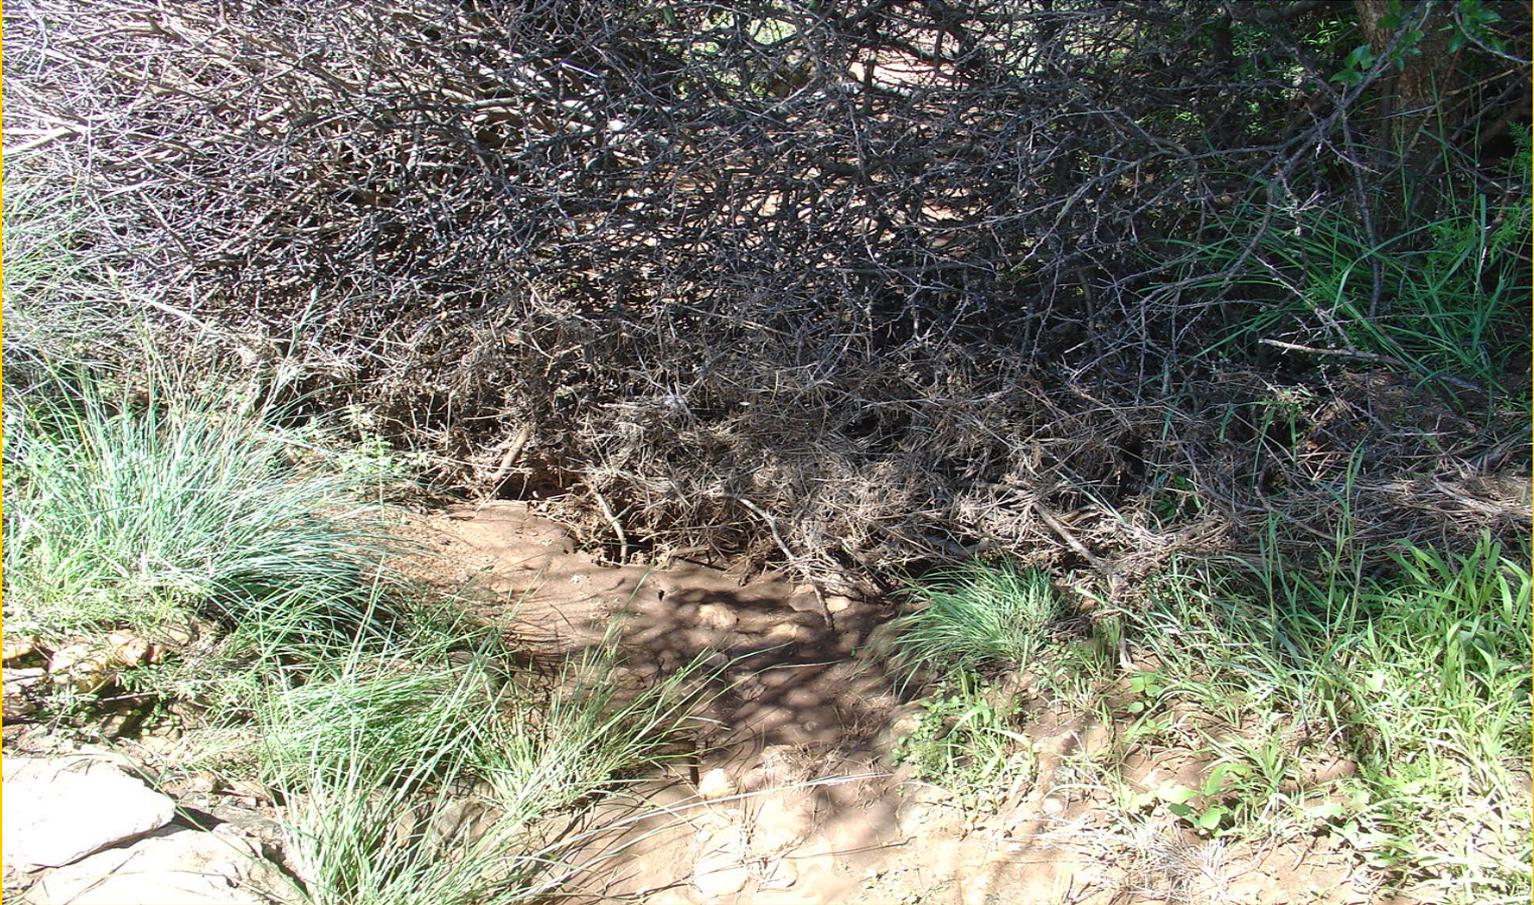
Both soil and organic matter were trapped by some filters during the rain.

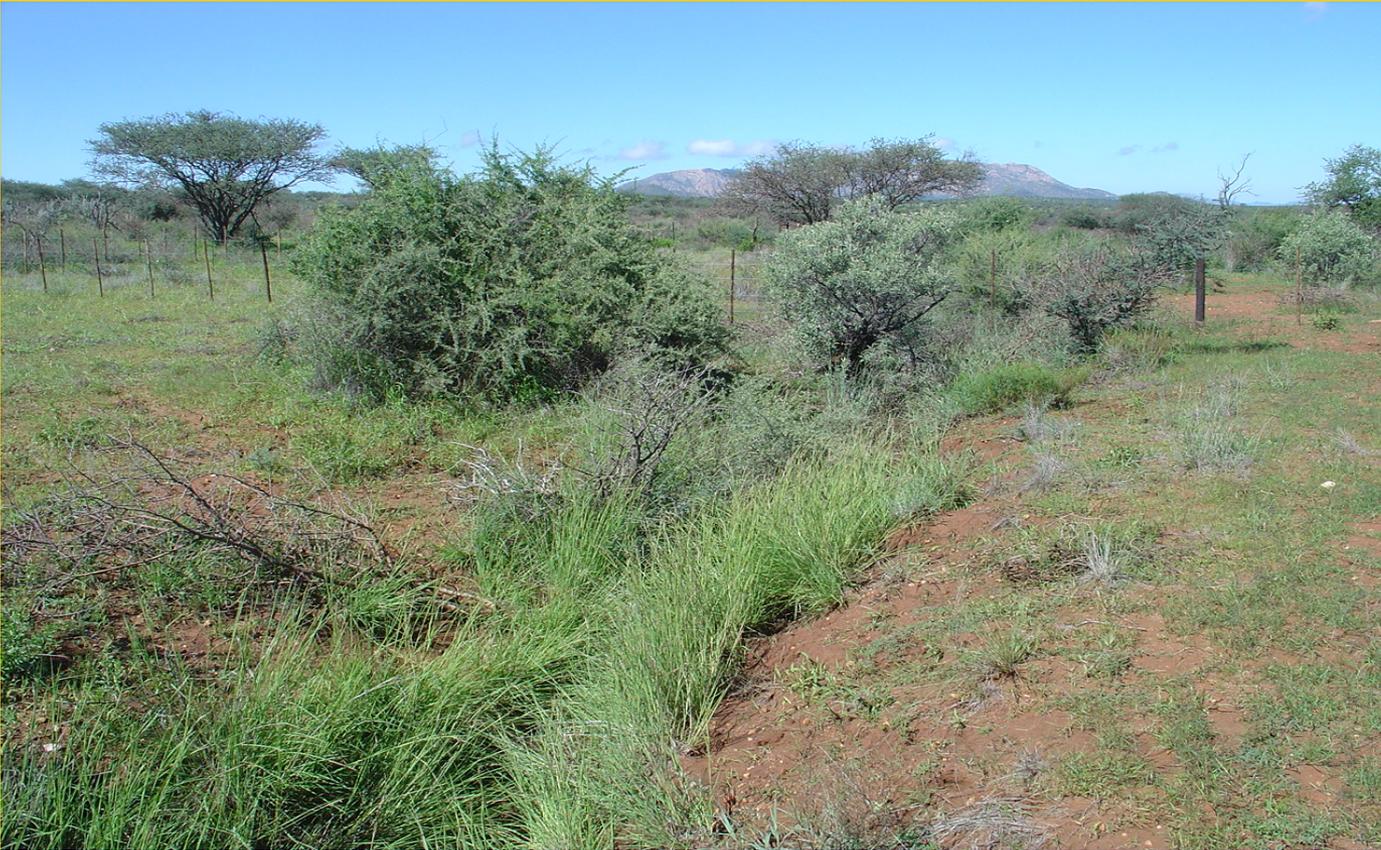
Perennial grasses established in the rills

- **Perennial grasses appear to be taking over the filtering function from the rotting branches**
- **There was no evidence that fencing helped the restoration process, so the grazing management seems OK**
- **Early response is critical to prevent gullies losing rain water and soil**

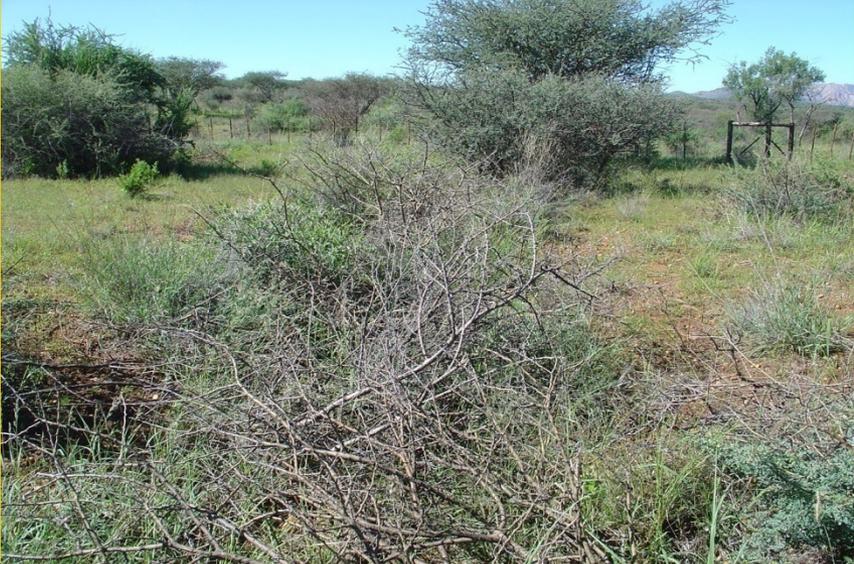
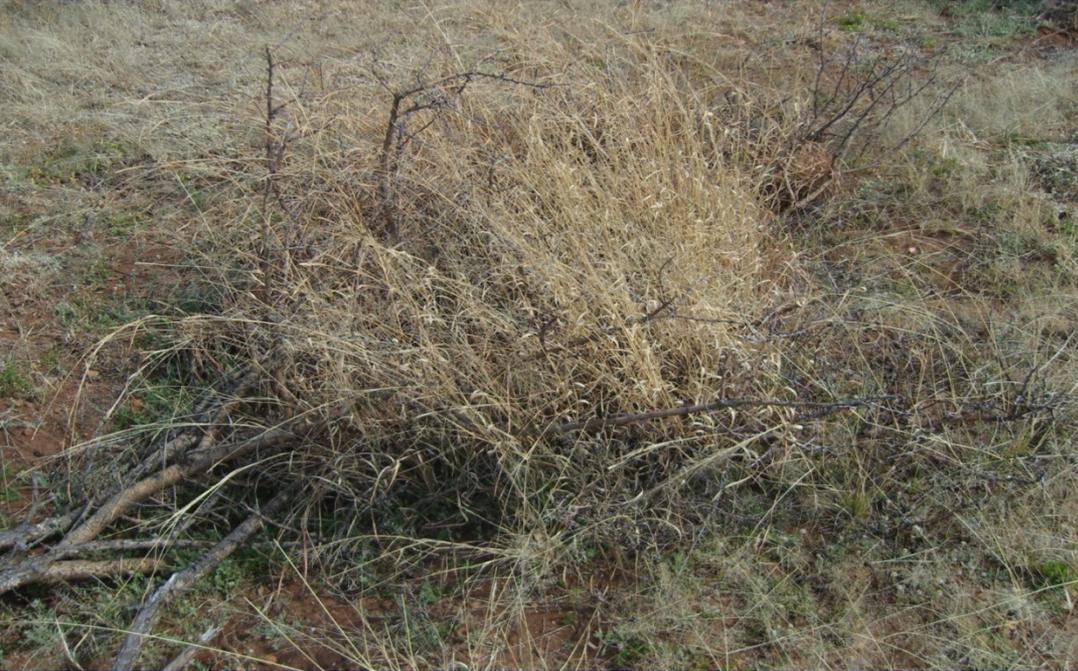
**More grasses growing
under individual filters**

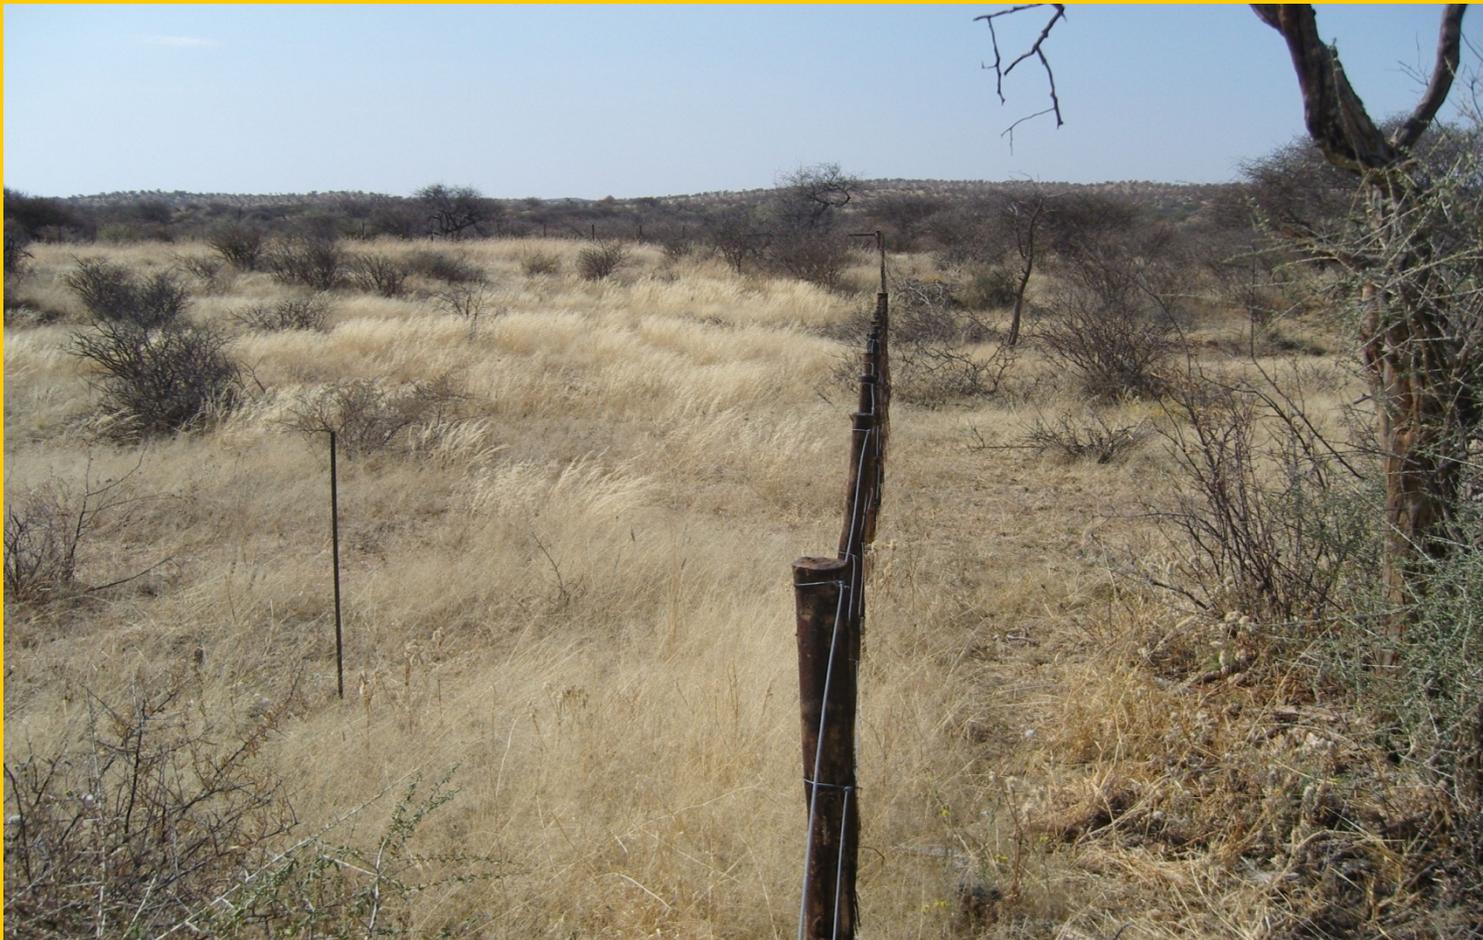
Higher grass biomass in fenced exclosures, but zero animal production

Lower grass biomass in surrounding camp, but higher density
